Technical Data Sheet

Bridge Identification:	1581510000000R03
Facility Carried:	I-75
Feature Intersected:	Raisin River
Location:	Frenchtown Township
County:	Monroe
Region:	University
Year Built:	1955
Year Reconstructed:	1987
Bridge Type:	Riveted Plate Girder System
No. of Spans:	11
Deck Area:	105,525 S.F.
Paint System:	Type 1
Paint Area:	260,500 S.F.

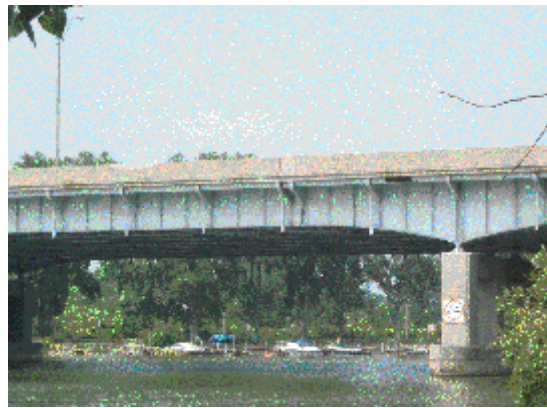
Pin and Hanger (4)

- ! Tension areas of main girders.** See Figure 1 in the Inspection and Maintenance Program section of this manual for tension areas of main girders.
- ! Pin and hanger assemblies.** (Photo 4) The suspended span has moved eastward to its limit. The hanger plates at this location are rubbing under live load, causing some wear. The pins and hanger plates should be carefully inspected.
- ! Floorbeam-to-girder connections.**
- ! Lateral bracing-to-girder connections.**

Recommendation	Schedule
Clean bridge drainage system components (deck drains and downspouts).	6 to 12 months
Flush bridge deck joints and check for and repair leaks.	12 months
Powerwash bridge superstructure and remove debris from around bearings.	12 months
Powerwash bearings and pin and hanger assemblies.	12 months
